**2025 Annual Landfill Inspection under
Coal Combustion Residuals Rule
Seminole Generating Station
Putnam County, Florida**

March 14, 2025

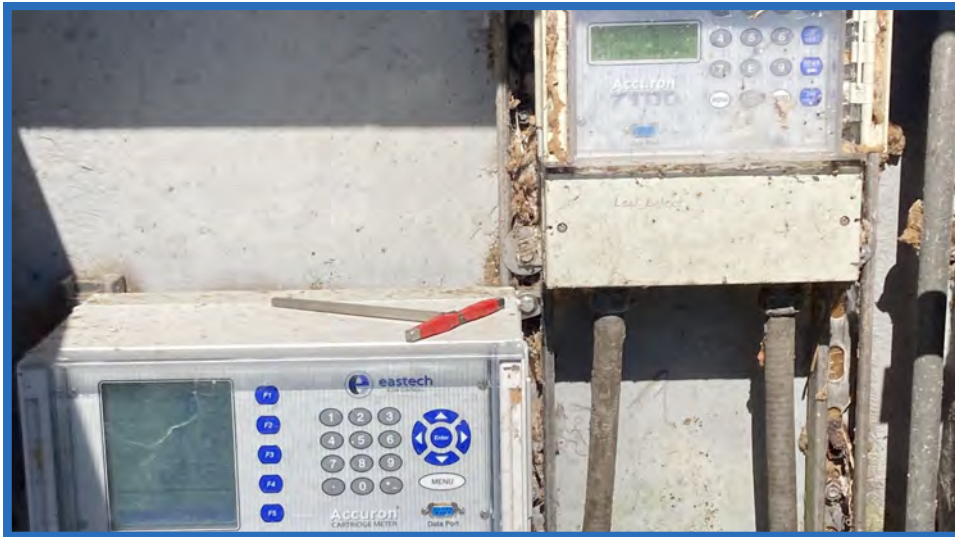
Leachate Collection (Left) and Leak Detection (Right) Flow Meter Control Panels for Increment 1

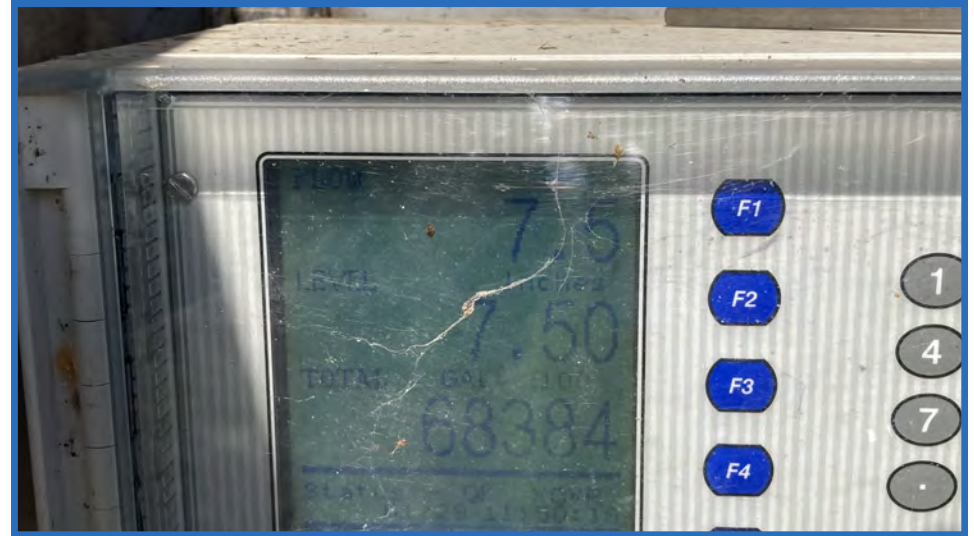
Display of Leachate Collection Flow Meter Control Panel for Increment 1

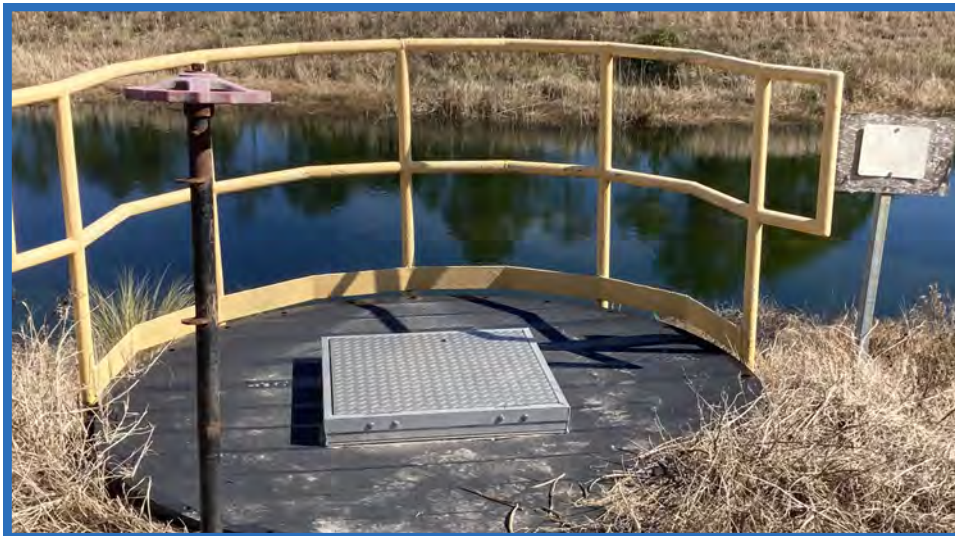
Leachate Collection and Leak Detection System Manhole for Increment 1

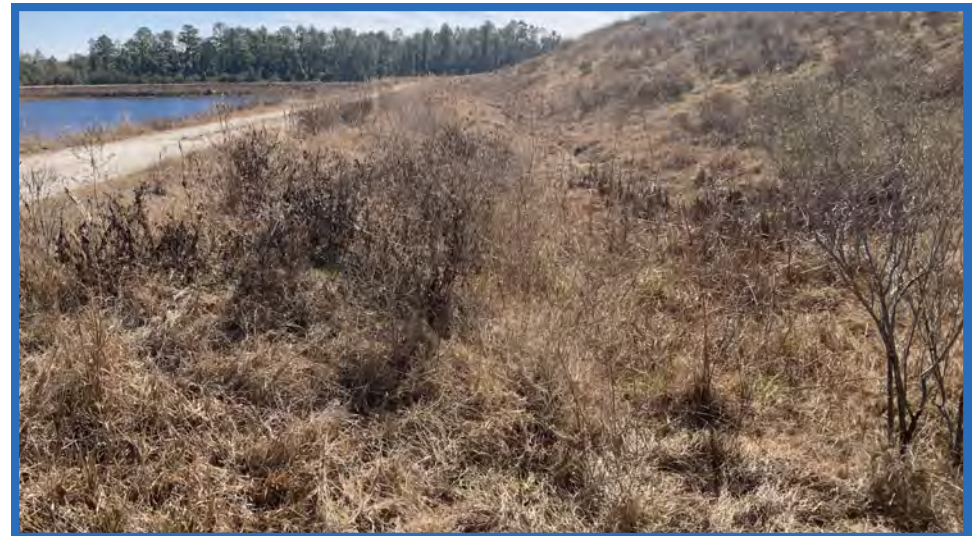
Sump Area of Increment I and Perimeter Swale East of Stage I, Looking South

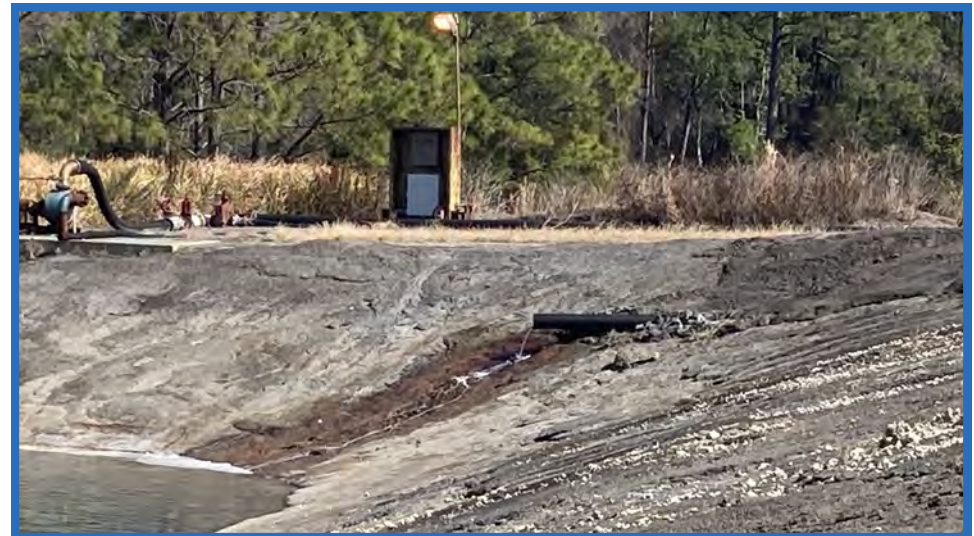
8-Inch Diameter HDPE Discharge Pipe from Increment 1 Leachate Collection and Leak Detection System into Pond 8

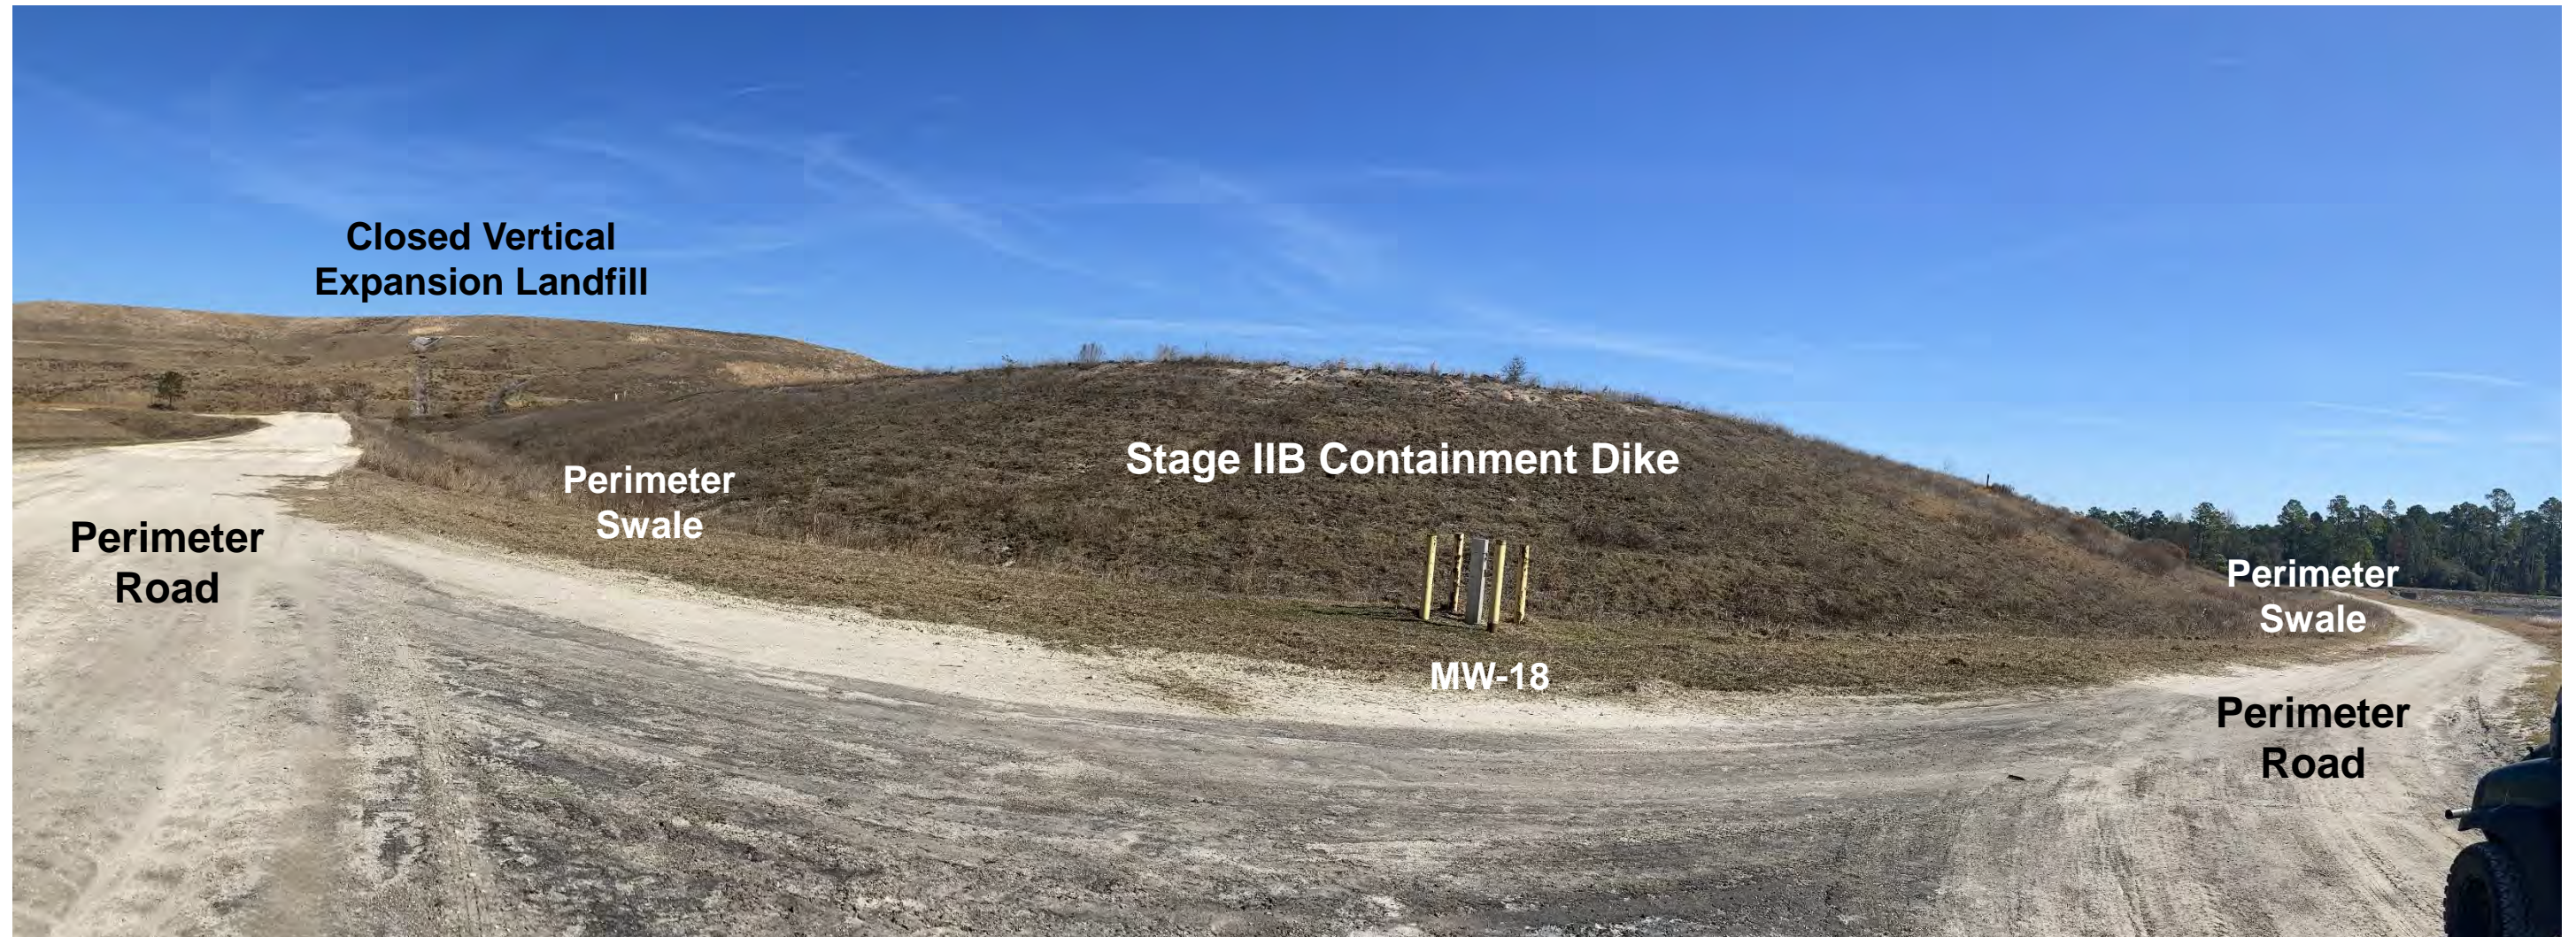
Panorama Along Perimeter Road and Swale, Looking Northeast from Perimeter Road at Southwestern Corner of Stage IIB Containment Dike
